Announcements

Found in the Field

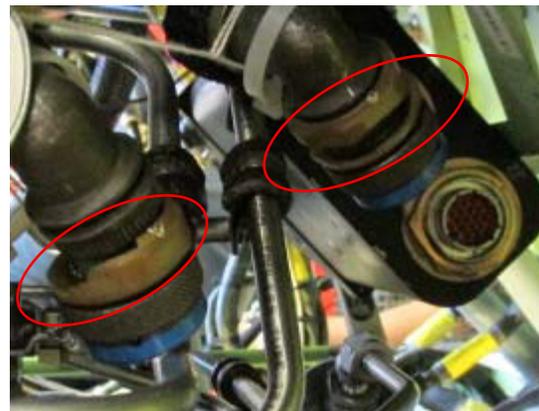
Recent inspections of naval aircraft have shown cracks and failures of composite accessories (Figures 3 through 6).

Figure 3: In The Fleet Cracked Size 14 Coupling Nuts

The success of the anti-rotation design feature of the M85049/91 accessory composite coupling nut combined with the probability for cracking damage caused by over-torque will lead to a requirement change. There will be a change of the specified accessory torques in SAE AS85049, followed by an update to the installation procedure in the NA 01-1A-505-1 (WP 024 00). The composite accessories will be installed hand tight plus 1/8 turn or torqued to the specified value using the hex or strap wrench only. For on-aircraft, inaccessible areas, hand tight will be acceptable. For the metallic accessories the same tools are employed, but to the higher torque values provided. To further clarify the two accessory removal and installation procedures (composite and metallic), two separate job performance aids (JPAs) videos were created and inserted in the maintenance manual. Updates are due out with Change 2 expected release by October 2016.

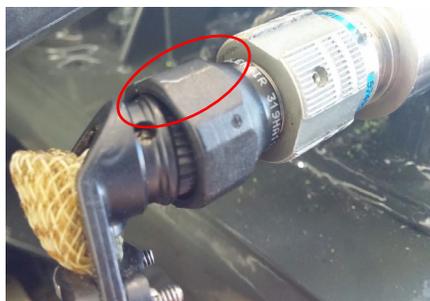
Figure 5: In The Fleet Cracked Size 9 Coupling Nuts

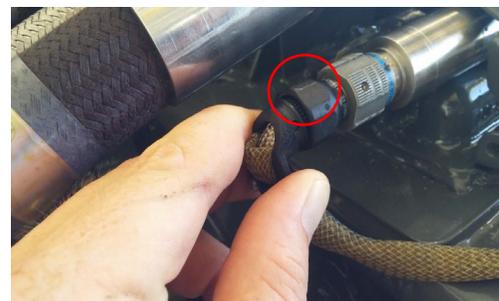
Figure 6: In The Fleet Cracked Size 9 Coupling Nuts

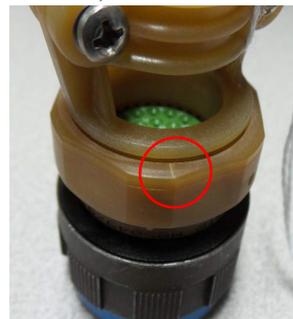
An engineering evaluation was performed to determine if the correct torques were being applied to the composite accessories in question. The evaluation confirmed tightening backshells to the recommended maximum torques would cause failure in some shell sizes. In looking at providing practical guidance to the maintainer, samples were tested to hand tight, hand tight plus 1/8 rotation and hand tight plus 1/4 rotation. These torques were applied with various tools available: hex pliers, crows foot wrench and strap wrench. It was found that on some sizes, even 1/8 turn past hand tight cracked the accessory coupling nuts (Figures 7 and 8).

Figure 7: Composite Backshell Coupling Nut Crack - 1/8 Turn Past Hand Tight
