FRCSE trainer repair team ensures aviator pipeline far into future

JACKSONVILLE, Fla. – Fleet Readiness Center Southeast (FRCSE) is making depot-level repairs and modifications at the facility to the Beechcraft T-44A and C model Pegasus King Air fleet used to train Navy and Marine Corps aviators on multi-engine aircraft at Naval Air Station (NAS) Corpus Christi, Texas.

The FRCSE T-44 Advanced Multi-Engine Trainer Team is overseeing a major rewire, Aircraft Condition Inspection (ACI), wing spar replacement and an upgrade to the avionics system with digital display converting the aircraft from an “A” to “C” model.

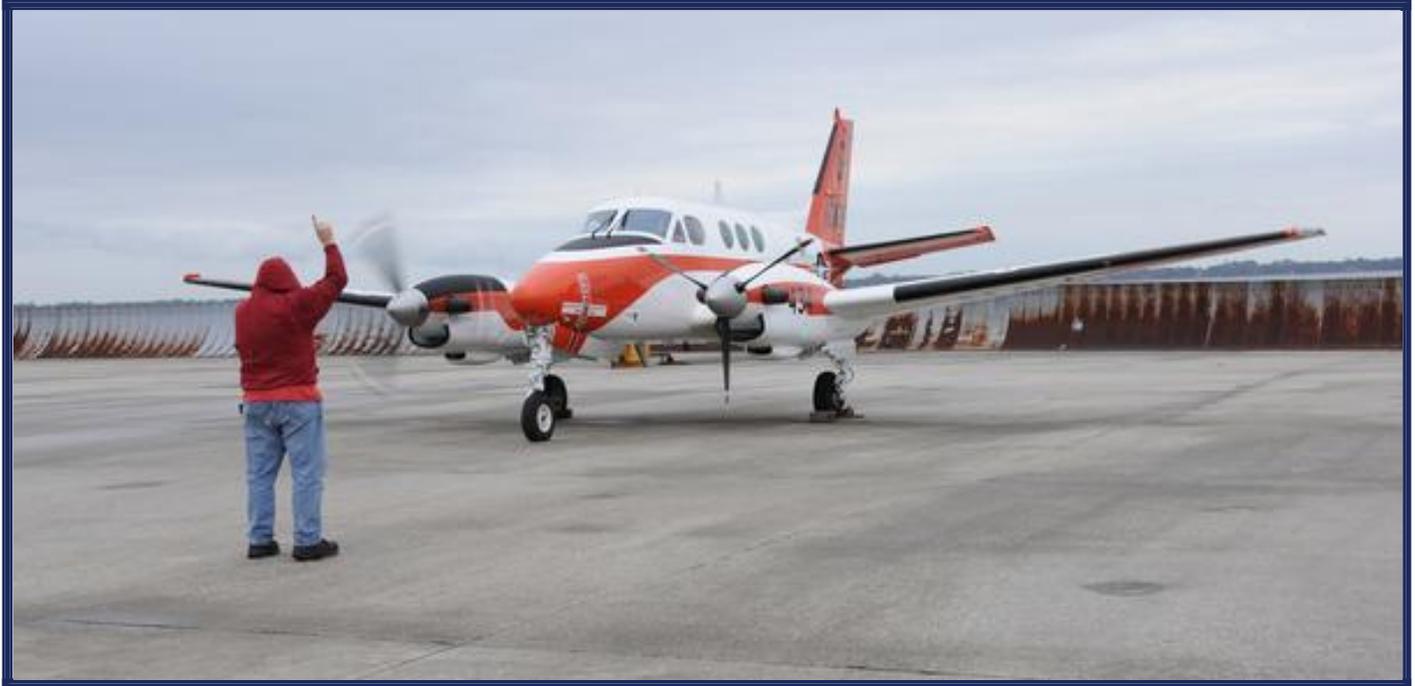
Fleet Readiness Center Southeast Flight Check personnel turn the propellers on a T-44C Pegasus King Air Trainer aircraft on the back flight line at Naval Air Station Jacksonville, Fla., Jan. 27. (U.S. Navy photo by Victor Pitts/Released)

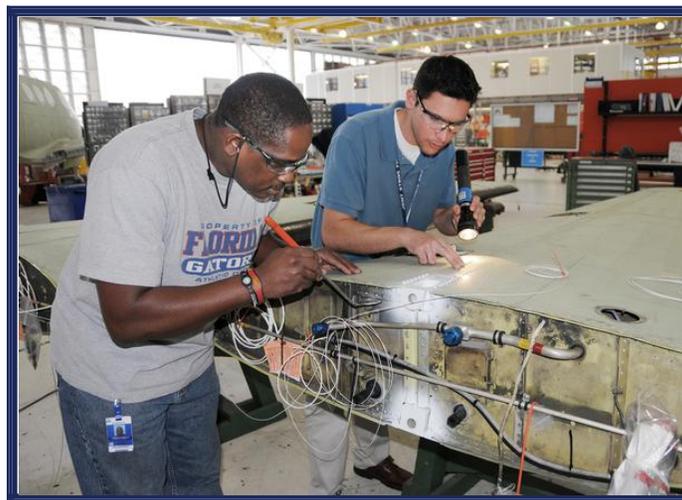
Overhaul and Repair Supervisor Tim Duncan (left) and T-44 Trainer Engineering Team Lead David Pfeffer inspect the wing butt joint and spar cap for corrosion on a T-44 Pegasus King Air trainer at Fleet Readiness Center Southeast Jan. 27. (U.S. Navy photo by Victor Pitts/Released)

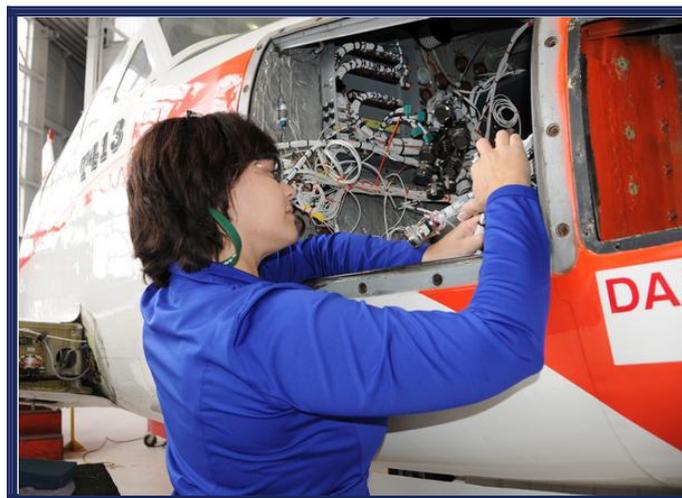
Electronics Engineer Charlotte Faulk, the T-44 avionics team lead, checks the nose wiring harness for an avionics systems upgrade on a Beechcraft T-44 Pegasus King Air Trainer at Fleet Readiness Center Southeast Jan. 27. Faulk headed efforts to reverse engineer wiring harnesses that run the length of the aircraft. (U.S. Navy photo by Victor Pitts/Released)

Electronics Engineer Charlotte Faulk, the avionics team lead, headed efforts to reverse engineer the wiring harnesses that run the length of the airframe. She created manufacturing drawings from the existing wiring diagrams and worked closely with FRCSE Cable Shop personnel who provided real-time feedback.

“We had five sets of harnesses from the vendor,” said Faulk. “The cable shop verified that the harnesses were built correctly and made wiring changes to the harnesses as necessary. They worked closely with engineering and the T-44 line artisans to create rewire harnesses that ran from wingtip to wingtip.”

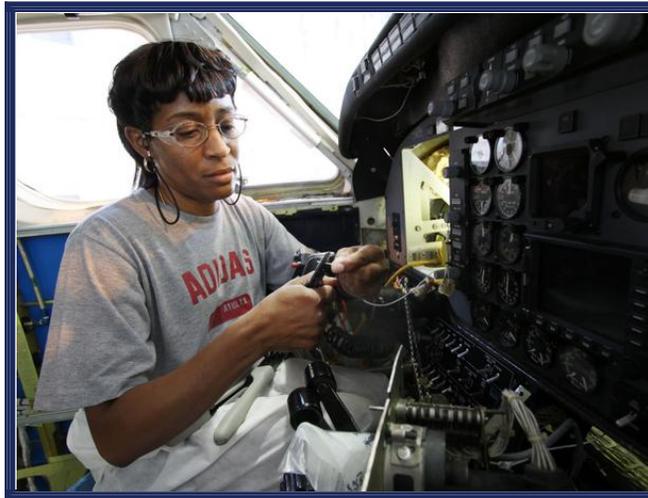
Aircraft Electrician Robin Anderson performs a wiring modification on the glass cockpit of a T-44 trainer aircraft at Fleet Readiness Center Southeast June 9, 2010. The Avionics Systems Upgrade with digital multifunction display converts the aircraft from an "A" to "C" model. (U.S. Navy photo by Victor Pitts/Released)

The Avionics System Upgrade (ASU) requires artisans to replace the T-44A’s analog steam gauge instrument panel and corresponding wire harnesses with a Rockwell Collins Pro-Line 21 avionics suite incorporating modern multifunctional color displays, AHRS and an Emergency Locator Transmitter (ELT).

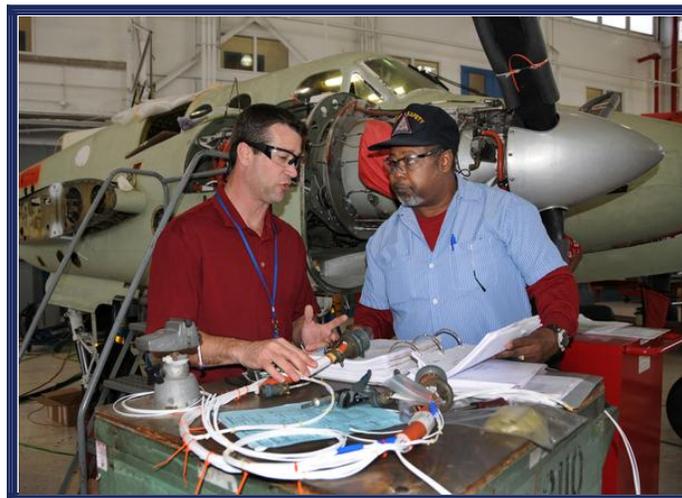
Trainer Aircraft Program Manager Bill Connelly (left) and Aircraft Electrician Paul Brown discuss the installation of an engine wiring harness on a trainer aircraft at Fleet Readiness Center Southeast Jan. 27. (U.S. Navy photo by Victor Pitts/Released)

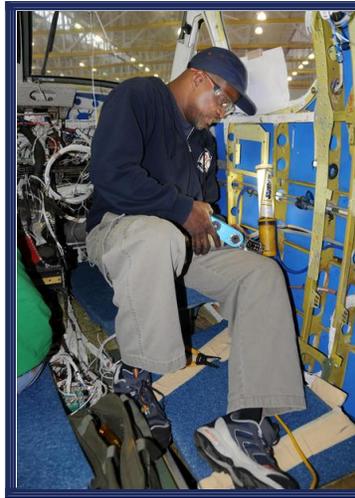
Aircraft Electrician Demetrius Henderson replaces a circuit breaker panel in the cockpit of a T-44 Pegasus King Air trainer at Fleet Readiness Center Southeast Jan. 27. (U.S. Navy photo by Victor Pitts/Released)

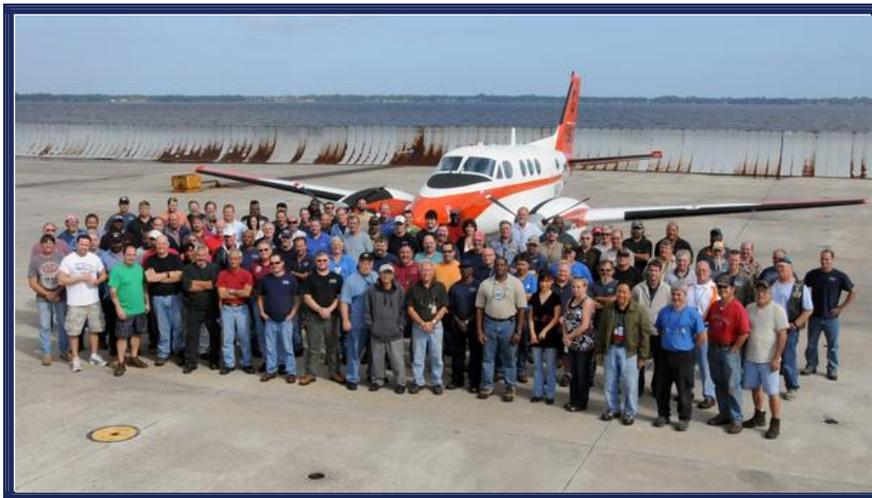
The Fleet Readiness Center Southeast T-44 Advanced Multi-Engine Trainer Team completes the first depot-level repairs and modifications including a major rewire, avionics systems upgrade with digital display, Aircraft Condition Inspection (ACI) and configuration updates to an aging trainer aircraft Nov. 8, 2011. The T-44 Trainer fleet supports the Chief of Naval Air Training mission of training Navy and Marine Corps pilots on multi-engine aircraft. (U.S. Navy photo by Victor Pitts/Released)

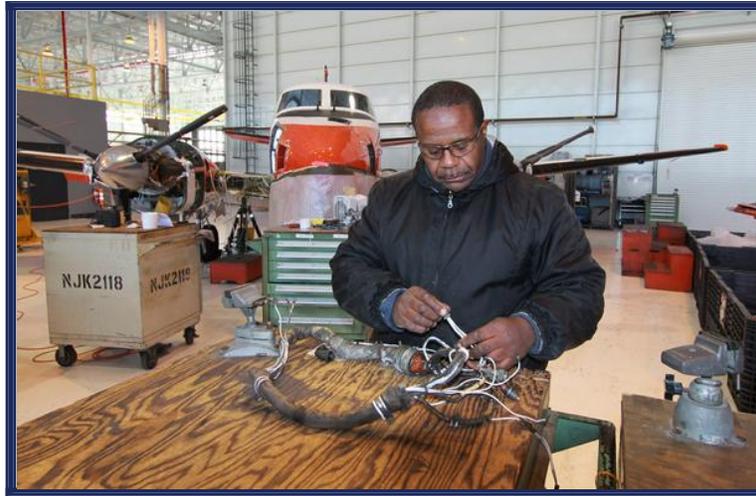
Aircraft Electrician Al Lambert inspects an engine control wiring harness from a T-44C Pegasus King Air aircraft at Fleet Readiness Center Southeast Jan. 14, 2011. The facility is implementing a rewire change, along with avionics upgrades to the aging trainer fleet. (U.S. Navy photo by Victor Pitts/Released)

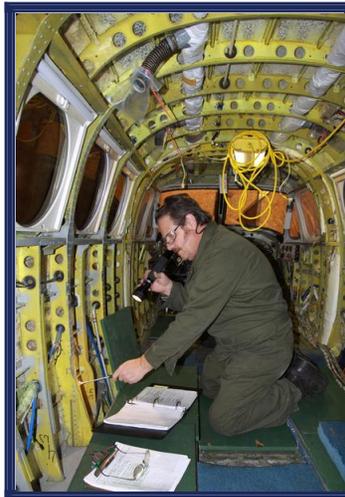
Sheet Metal Examiner/Evaluator Stan Kennedy performs a structures inspection on the interior cabin airframe of a T-44 Pegasus King Air Trainer at Fleet Readiness Center Southeast Jan. 14, 2011. (U.S. Navy photo by Victor Pitts/Released)

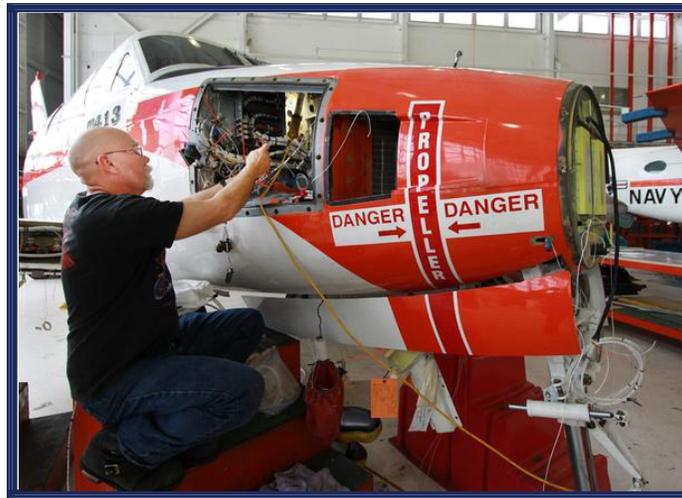
Aircraft Electrician Bruce Arthur installs wiring on a T-44 turboprop trainer aircraft undergoing an upgrade from an "A" to "C" model at Fleet Readiness Center Southeast Feb. 21. (U.S. Navy photo by Marsha Childs/Released)

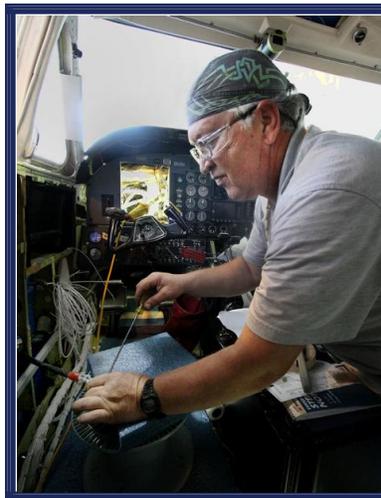
Aircraft Electrical Worker Ronald Johnson upgrades the avionics systems in the cockpit of a T-44 Pegasus trainer aircraft at Fleet Readiness Center Southeast June 9, 2010. The upgrades convert the aircraft to a glass cockpit that features electronic digital displays. (U.S. Navy photo by Victor Pitts/Released)

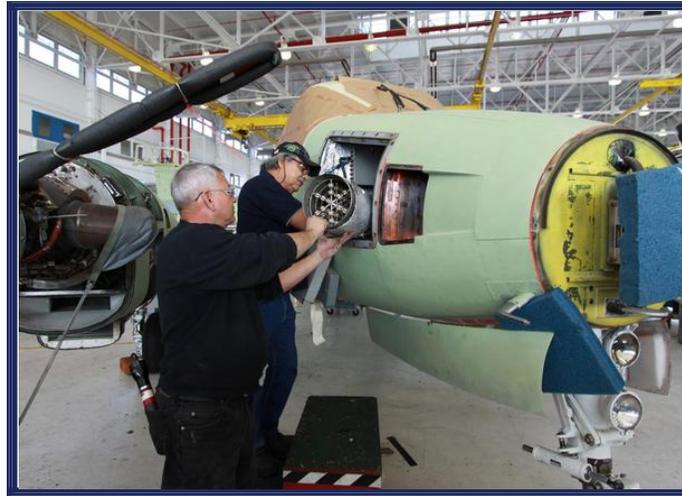
Aircraft Mechanic Michael Dooley (left) and Aircraft Examiner and Evaluator Alvaro Marquez remove the cabin heater from a T-44 Pegasus King Air trainer in a production hangar during aircraft modifications at Fleet Readiness Center Southeast Jan. 14, 2011. The trainer fleet is undergoing major upgrades to keep the platform flying until its planned sundown in 2025. (U.S. Navy photo by Victor Pitts/Released)
