New fiber-optic support equipment is looking quite FOCSE to the fleet

NAVAL AIR SYSTEMS COMMAND, PATUXENT RIVER, Md. – The Navy has developed new fiber-optic support equipment that will decrease the number of aircraft avionics systems turned in for repair and recertification.

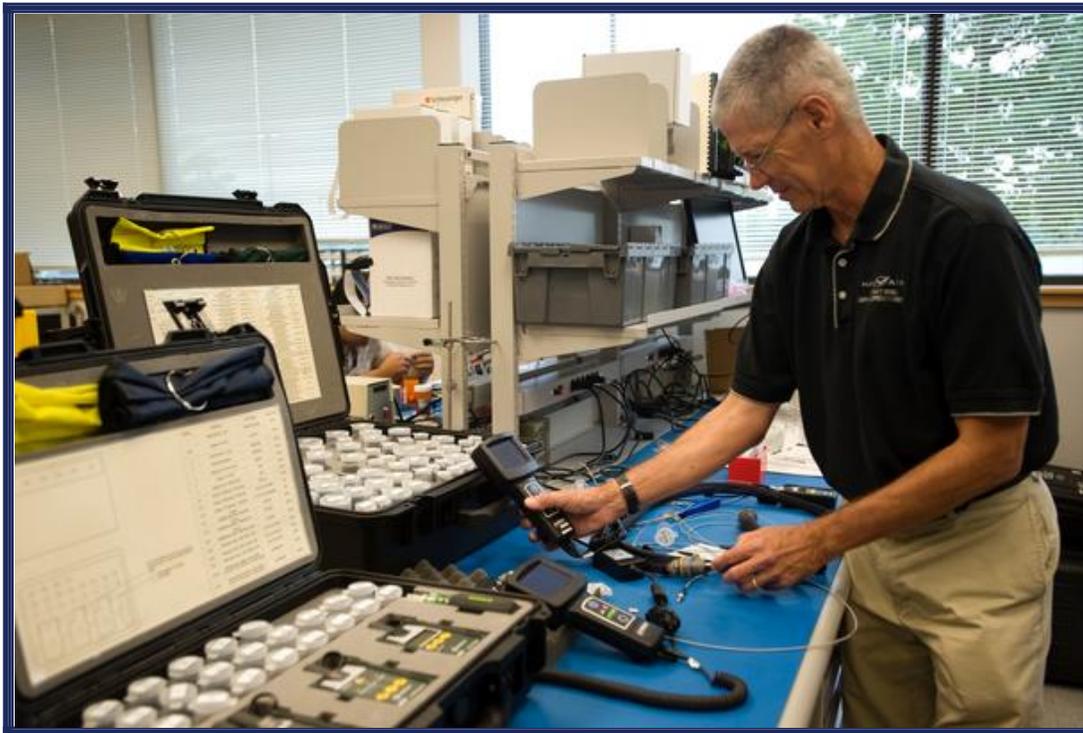
Art Michon, principal design engineer for the Fiber Optic Common Support Equipment, demonstrates how to use the fiber-optic inspection equipment in a wiring lab on Joint Base McGuire-Dix-Lakehurst, N.J., in July. (U.S. Navy photo)

Since fiber-optic links are highly sensitive to dust and dirt, maintainers will use the FOIS, which consists of a camera inspection probe/magnifier and display monitor, to examine the ends of fiber links. If contamination is present, special swabs are used to clear the debris from the end of the fiber.
